The Columbia Accident: Synopsis of CAIB Report* Regarding the Physical Cause of the Accident and and Personal Thoughts

James O. Arnold, Ph.D

***Seminar based on CAIB Appendix F2, Vol IV
by J. O. Arnold, H. E. Goldstein and D. J. Rigali**

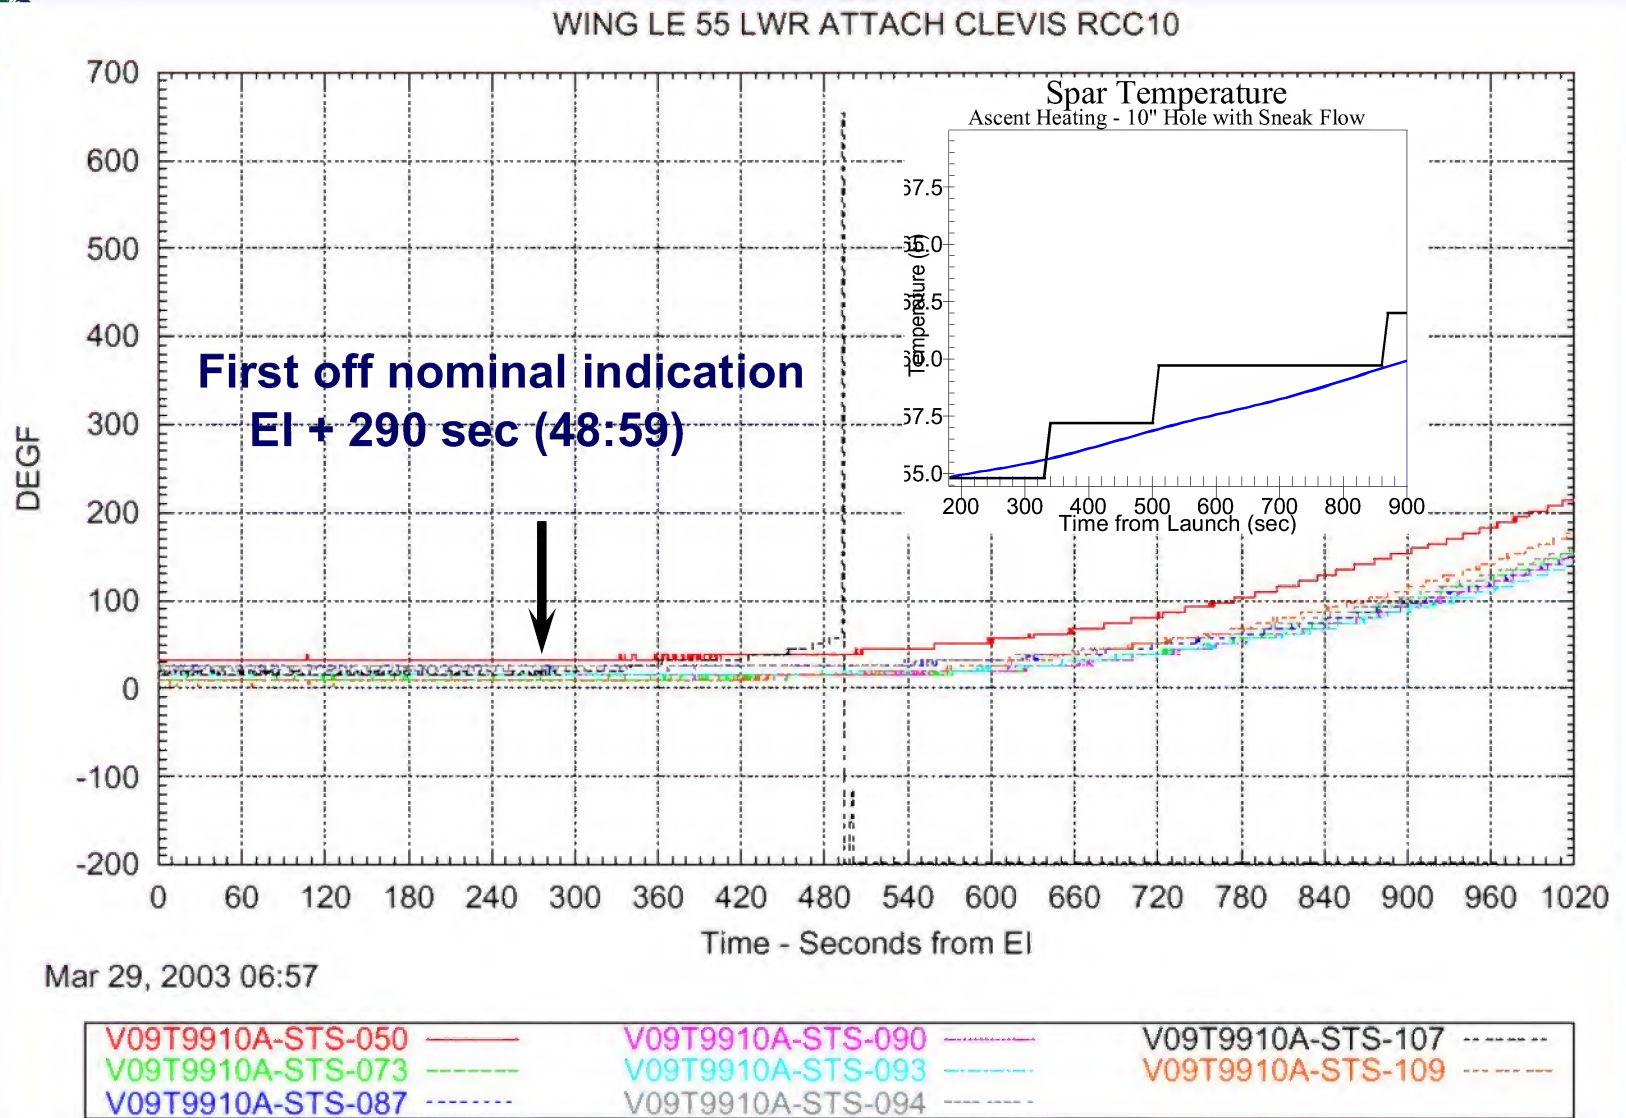
OEX STS-107 Flight Data and Thermal Analysis by JSC/C. Madden

48:39 (EI+270 seconds) RCC panel 9 spar insulator strain gage (V12G9921) shows off nominal increase. Thermal stresses build due to the breach in the wing and hot gas impingement on the spar. Pressure also starts to build in the RCC wing cavity adding to the load on the spar. All these loads combine and put an off nominal strain on the spar. Fig. 10

48:59 (EI+290 seconds) Hot gas continues to flow into the RCC cavity through the damaged RCC panel 8. Heat entering RCC cavity is first registered by the temp sensor (RTD) on RCC panel 9/10 clevis fitting (V09T9910). Fig. 11

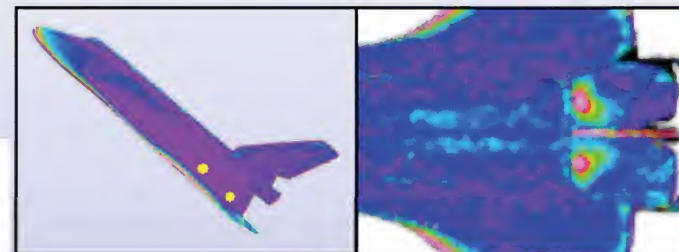
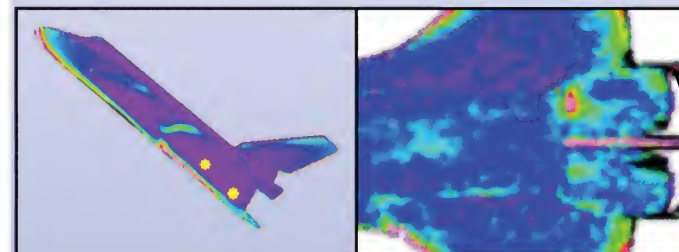
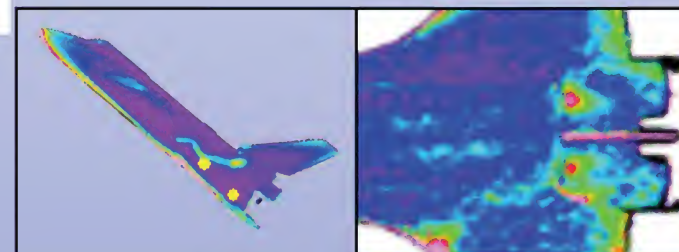
Wing leading edge damage influences leeside flowfield

Baseline

Missing panel #5

Missing panel #10

Note cooling trend on left OMS pod

49:49 (EI+340 seconds) OMS pod temperatures initially become cooler than nominal due to leading edge RCC panel damage, as confirmed by LaRC wind tunnel tests. Figs 12 and 13

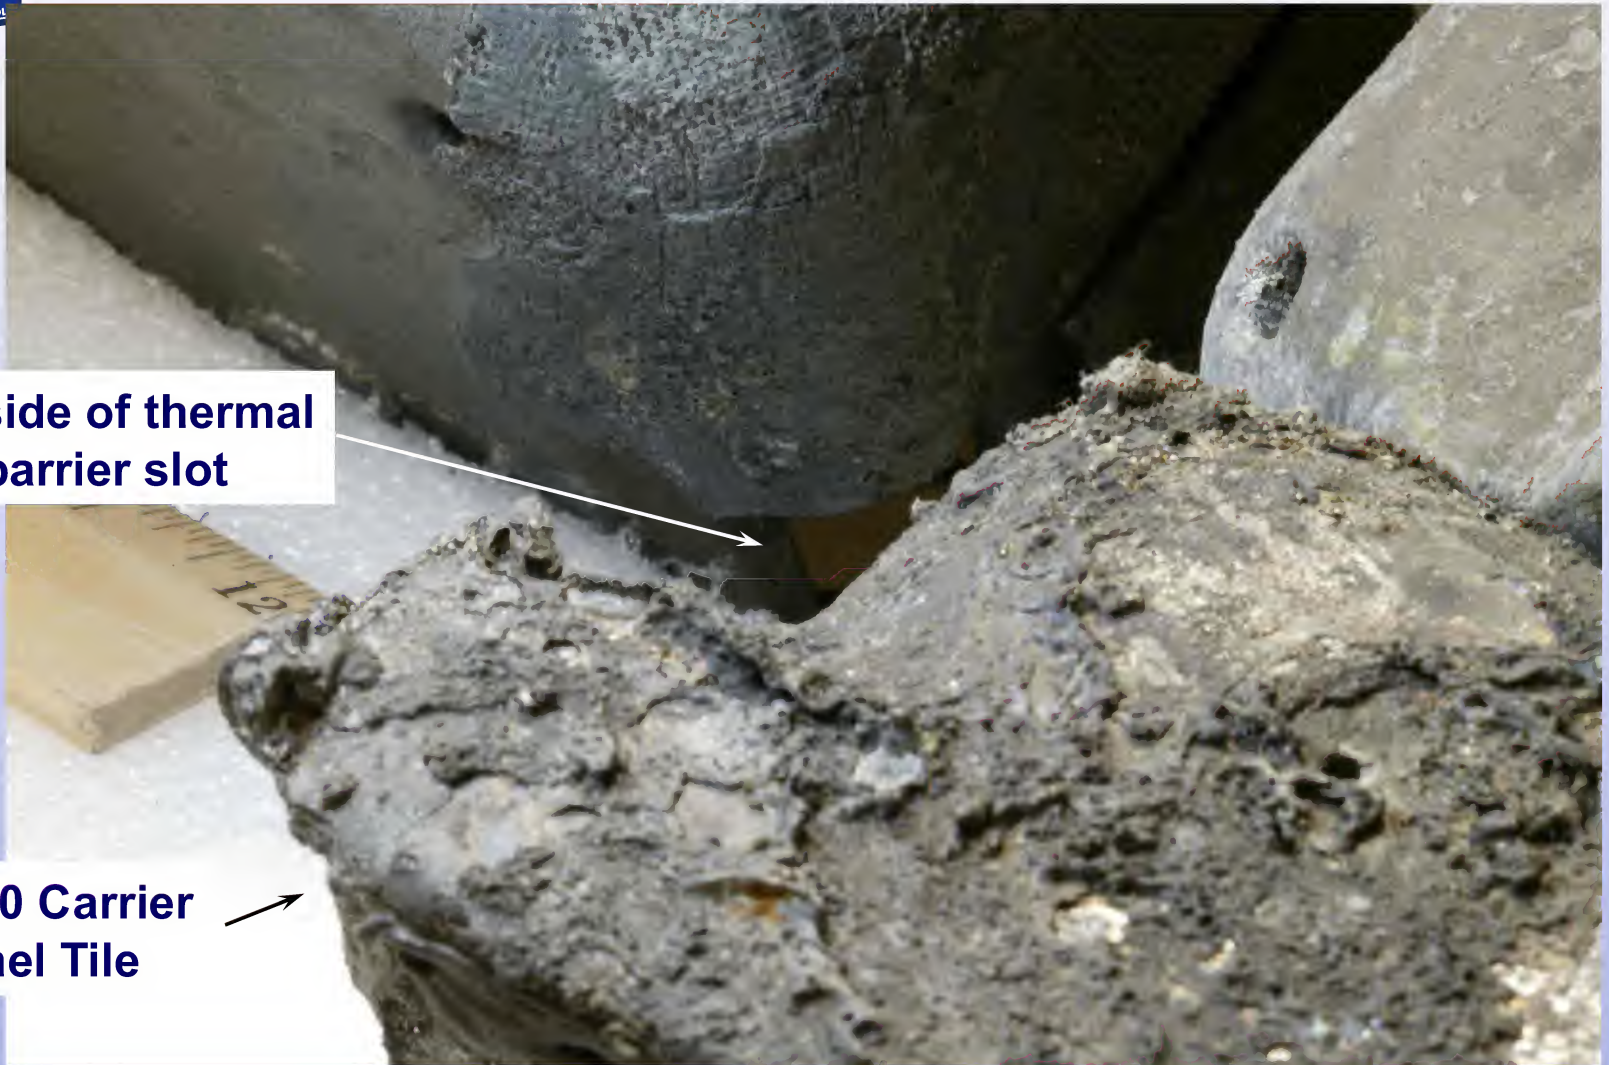
Close up of lower edge of panel 8/9

Outside of thermal
barrier slot

LI 2200 Carrier
Panel Tile
